PIPELINE ACCIDENT REPORT

MID-AMERICA PIPELINE SYSTEM
LIQUEFIED PETROLEUM GAS PIPELINE
RUPTURE AND FIRE
DONNELLSON, IOWA
AUGUST 4, 1978

1. Report No. NTSB-PAR-79-1		2. Government Accession No.		3. Recipient's Catalog No.	
4. Title and Subtitle Pipeline Accident Report -- Mid-America Pipeline System Liquefied Petroleum Gas Pipeline Rupture and Fire, Donnellson, Iowa, August 4, 1978				5. Report Date May 3, 1979

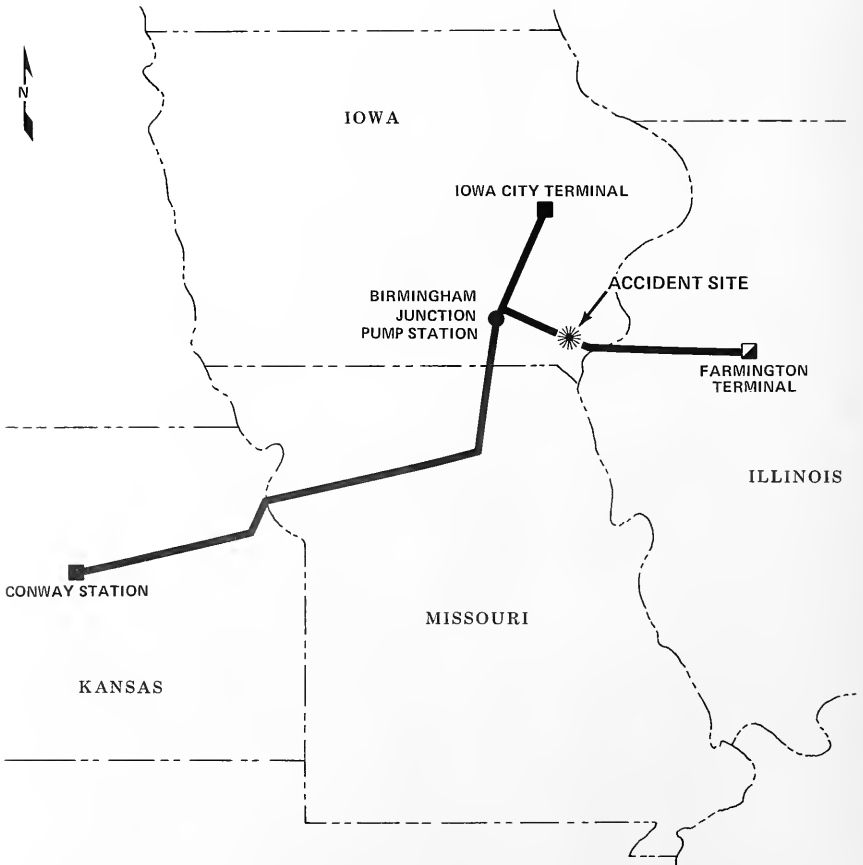
Figure 2. Plan view of pipeline route.

The dispatcher had requested the Iowa City terminal to open a suction pressure control valve there on the main line (see figure 2) sometime between 11 p.m. and midnight. The dispatcher said he thought that the valve might have been opened more than necessary; this would have caused such a pressure drop. Therefore, he did not immediately suspect a leak in the system.

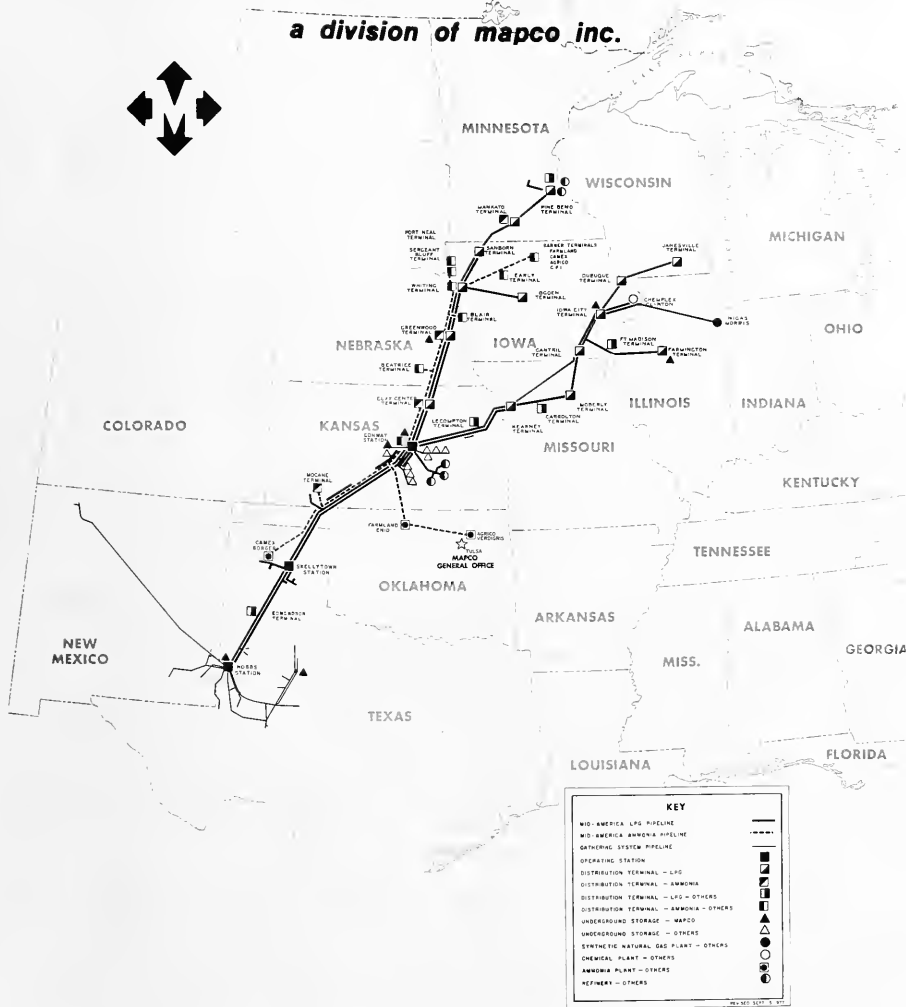
Figure 5. MAPCO pipeline system.

MAPCO, a common carrier LPG pipeline, extends from west Texas to Conway, Kansas, where it forms two branches. One branch extends to Minneapolis, Minnesota and the other extends to Janesville, Wisconsin. The pipeline system contains more than 5,000 miles of multiple lines from 4 inches to 12 inches in diameter which cross the States of New Mexico, Texas, Oklahoma, Kansas, Nebraska, Missouri, Iowa, Illinois, Minnesota, and Wisconsin. MAPCO transports eight liquefiable hydrocarbons. Ethane-propane mix, propane, iso-butane, normal butane, butane mix, natural gasoline, and a demethanized mix. The original system constructed in 1960 consisted of 2,200 miles of pipelines. Additional lines were added in 1961, 1967, 1968, 1969, and later. (See figure 5.)

two legs of the pipeline from Conway north. (See figure 5.) During the day, a supervisor and four other persons are also on duty at the control center.

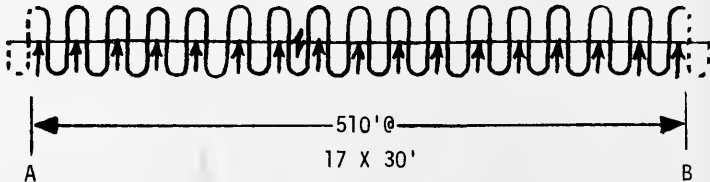
Figure 1.

e. Stress due to earth fill

Now it is possible that this earth loading tried to lift the pipe to the left of A (Point A shown in Figure 1)
